**Flood Control Project Maintenance
Levee Inspections**

2011 Channel Summary Report

Madera County FCWCA

Flood Control Project Maintenance**Unit Cover Sheet****2011 Channel Inspection Results****Madera County FCWCA**

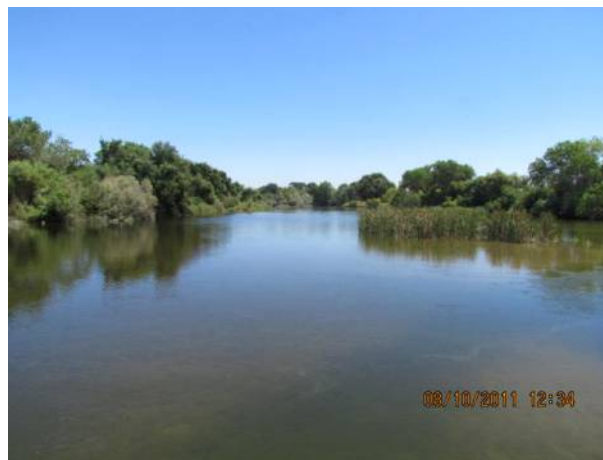
richard_c_20110831_022.jpg

Looking upstream from the Ash Slough & Chowchilla River headwall.

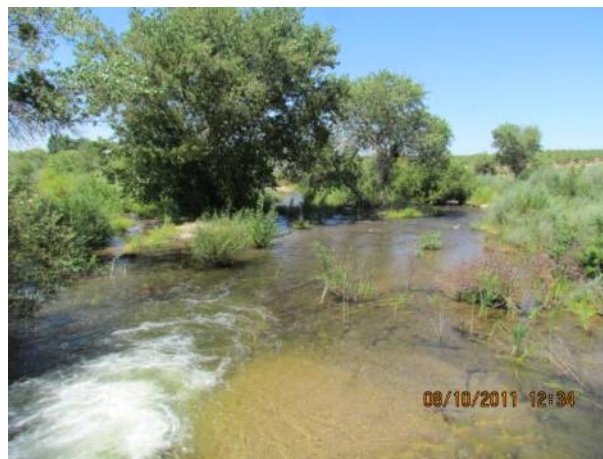
richard_c_20110831_023.jpg

Looking downstream from the Ash Slough headwall.

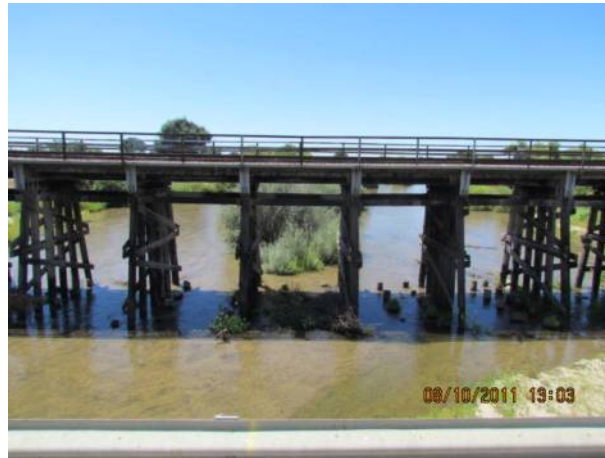
richard_c_20110831_025.jpg

Looking downstream from Santa Fe Dr.

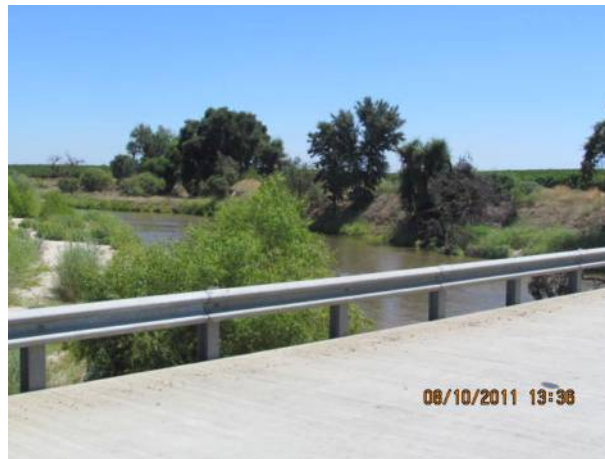
richard_c_20110831_026.jpg

Looking upstream from Road 19

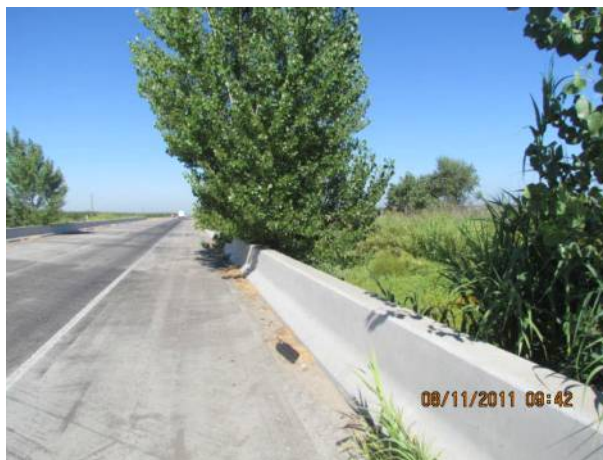
Levee Mile Report Line	75
Start Levee Mile	0.00
End Levee Mile	0.00
Location	
Category	Channels
Item	Vegetation & Obstructions
Looking east at trees established near Hwy 152 bridge.	
richard_c_20110901_037.jpg

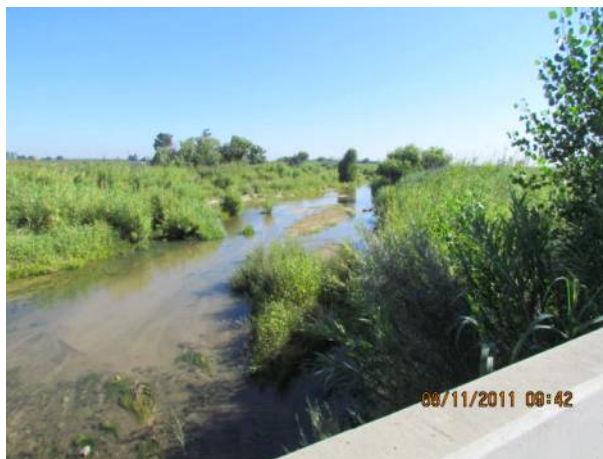
Levee Mile Report Line	75
Start Levee Mile	0.00
End Levee Mile	0.00
Location	
Category	Channels
Item	Vegetation & Obstructions
Looking downstream from Hwy 152.	
richard_c_20110901_038.jpg

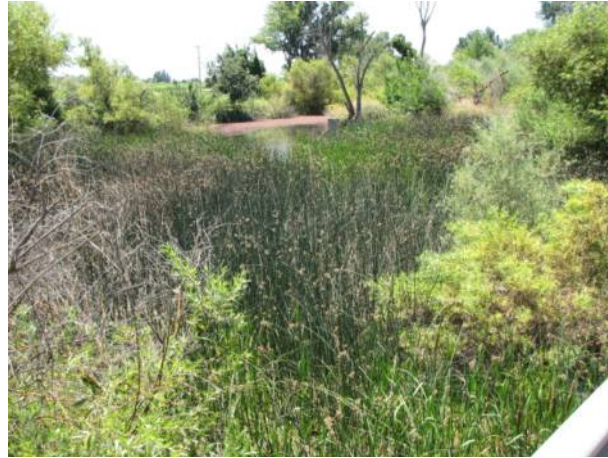
Levee Mile Report Line	16
Start Levee Mile	0.00
End Levee Mile	0.00
Location	
Category	Channels
Item	Vegetation & Obstructions
Looking downstream from Avenue 26 at heavy growth of willows, bamboo and tules growing wild in channel. Photo taken 7-20-2011.	
phillips_c_20110804_056.jpg

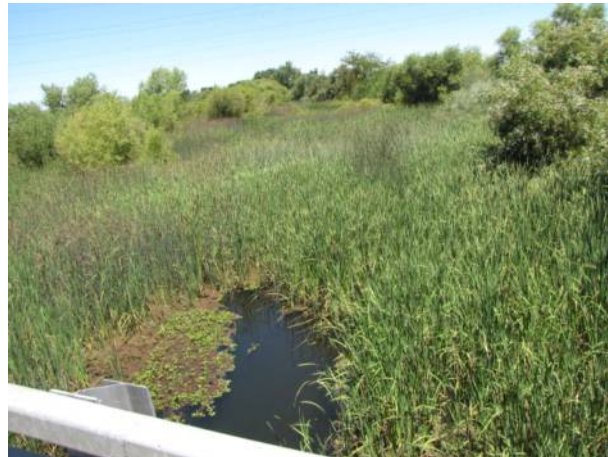
Levee Mile Report Line	21
Start Levee Mile	0.00
End Levee Mile	0.00
Location	
Category	Channels
Item	Vegetation & Obstructions
Looking upstream from Road 19. Photo taken 7-20-2011.	
phillips_c_20110804_057.jpg

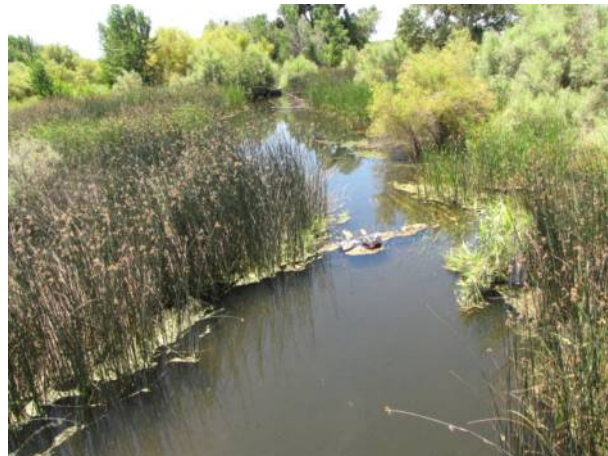
Levee Mile Report Line	26
Start Levee Mile	0.00
End Levee Mile	0.00
Location	
Category	Channels
Item	Vegetation & Obstructions
From road 19 looking downstream, channel flow diverted by wild growth. Photo taken 7-20-2011.	
phillips_c_20110804_058.jpg

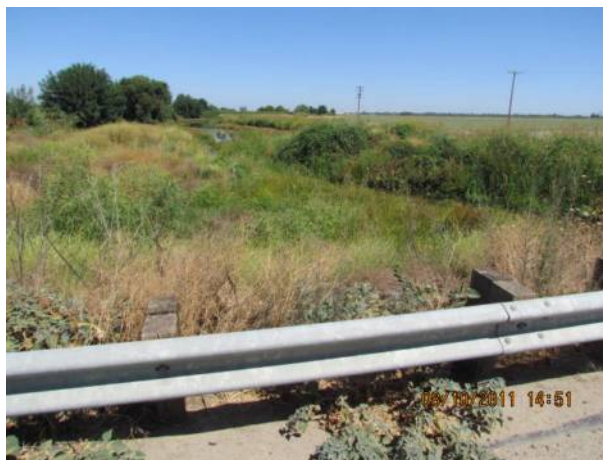
Levee Mile Report Line	31
Start Levee Mile	
End Levee Mile	
Location	
Category	Channels
Item	Vegetation & Obstructions
Looking upstream from Road 13 or Vista Road	
richard_c_20110831_009.jpg

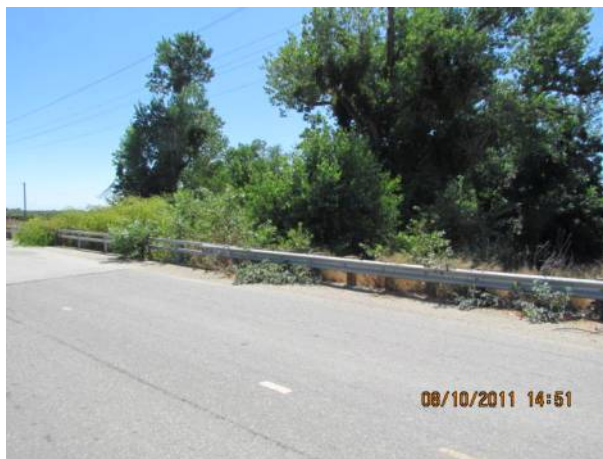
Levee Mile Report Line	36
Start Levee Mile	
End Levee Mile	
Location	
Category	Channels
Item	Vegetation & Obstructions
Looking downstream for Road 13 or Vista Road.	
richard_c_20110902_022.jpg

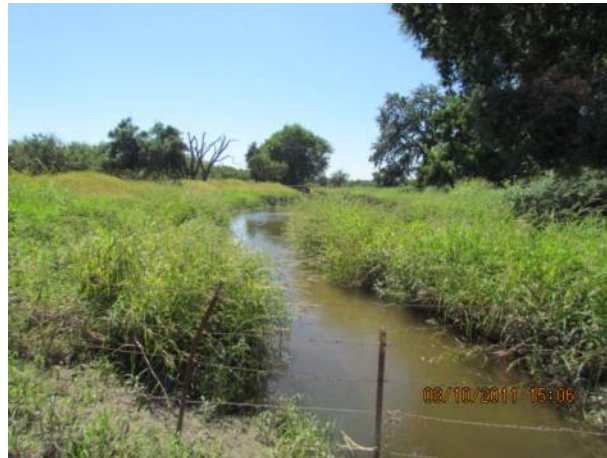
Levee Mile Report Line	56
Start Levee Mile	
End Levee Mile	
Location	
Category	Channels
Item	Vegetation & Obstructions
Looking downstream from Road 11 (low water crossing)	
richard_c_20110831_012.jpg

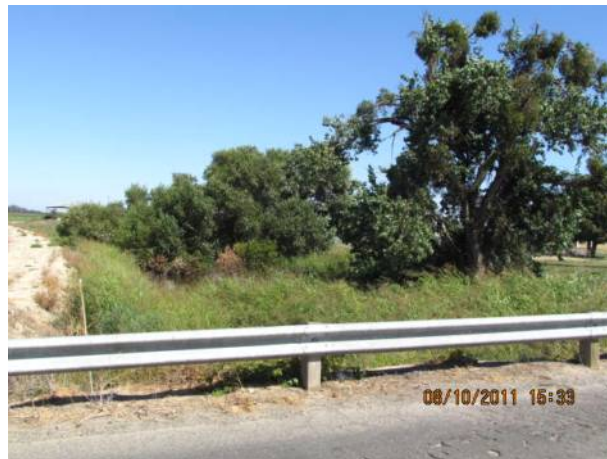
Levee Mile Report Line	61
Start Levee Mile	
End Levee Mile	
Location	
Category	Channels
Item	Vegetation & Obstructions
Looking upstream from Road 9 or Bliss Road.	
richard_c_20110831_013.jpg

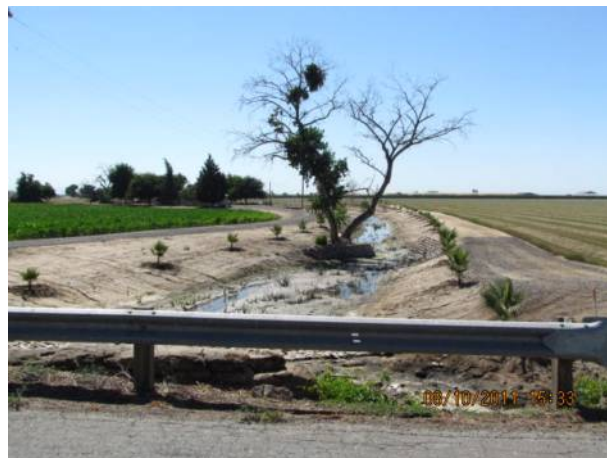
Levee Mile Report Line	66
Start Levee Mile	
End Levee Mile	
Location	
Category	Channels
Item	Vegetation & Obstructions
Looking downstream for Road 9 or Bliss Road.	
richard_c_20110831_014.jpg

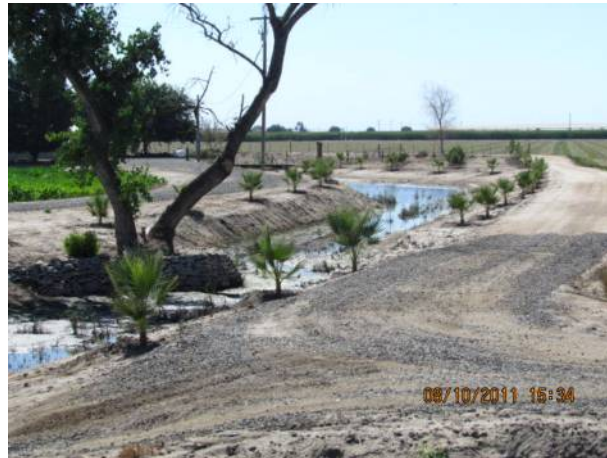
Levee Mile Report Line	70
Start Levee Mile	
End Levee Mile	
Location	
Category	Channels
Item	Encroachments
Looking downstream at palm trees planted in channel.	
richard_c_20110831_015.jpg

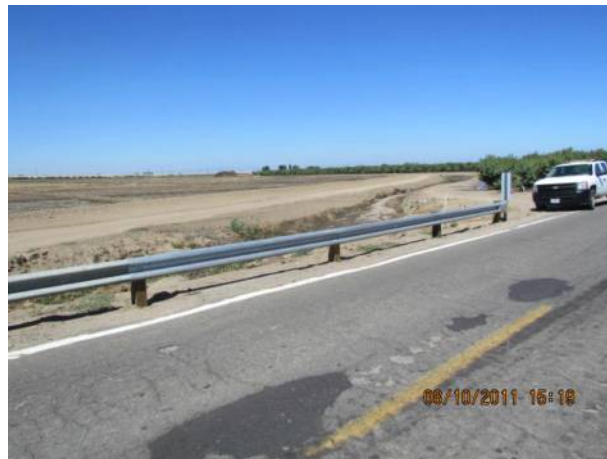
Levee Mile Report Line	71
Start Levee Mile	
End Levee Mile	
Location	
Category	Channels
Item	Vegetation & Obstructions
Looking upstream from Avenue 25 or Washington Road.	
richard_c_20110831_016.jpg

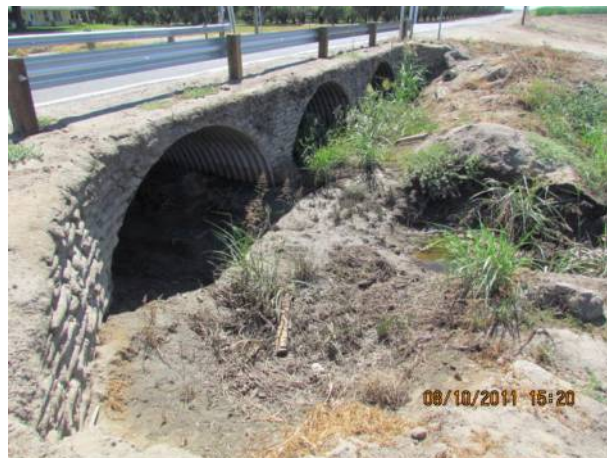
Levee Mile Report Line	72
Start Levee Mile	
End Levee Mile	
Location	
Category	Channels
Item	Shoaling / Sedimentation
Looking southwest at sediment in front of culverts.	
richard_c_20110831_017.jpg

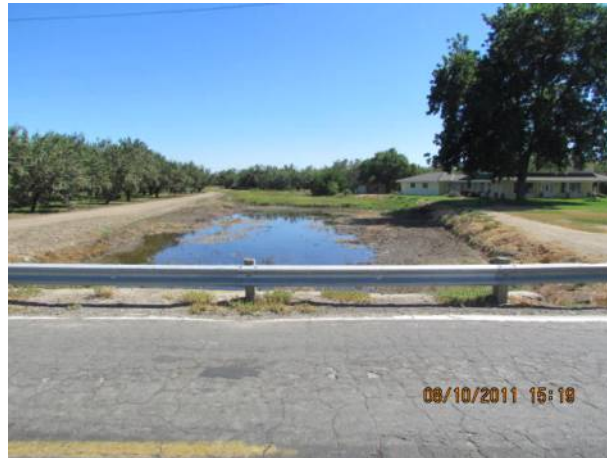
Levee Mile Report Line	76
Start Levee Mile	
End Levee Mile	
Location	
Category	Channels
Item	Vegetation & Obstructions
Looking downstream from Avenue 25 or Washington Road.	
richard_c_20110831_018.jpg

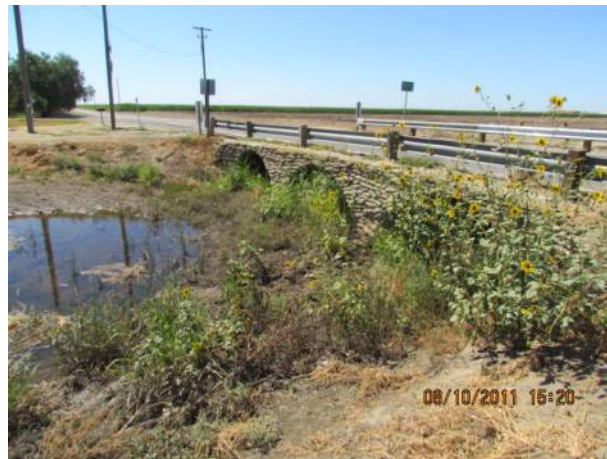
Levee Mile Report Line	77
Start Levee Mile	
End Levee Mile	
Location	
Category	Channels
Item	Shoaling / Sedimentation
Looking northeast at minimal amount of sedimentation in front of culverts.	
richard_c_20110831_019.jpg

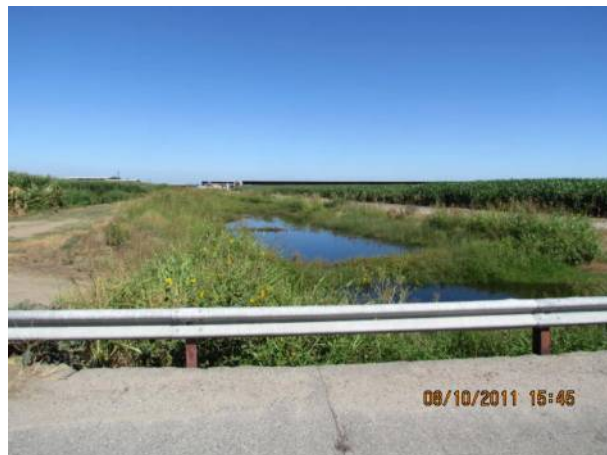
Levee Mile Report Line	81
Start Levee Mile	
End Levee Mile	
Location	
Category	Channels
Item	Vegetation & Obstructions
Looking upstream from Shultz Road & Road 5 1/2	
richard_c_20110831_020.jpg

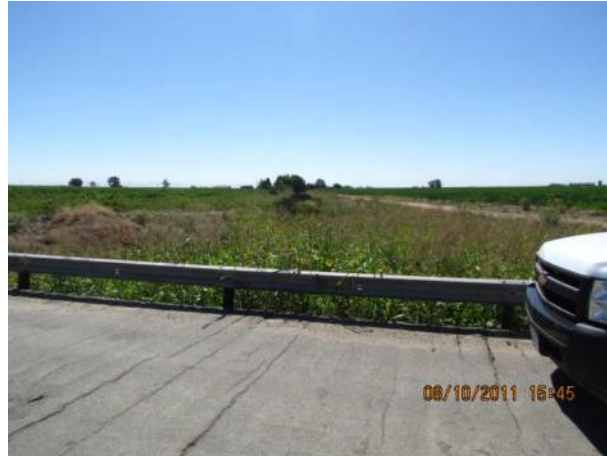
Levee Mile Report Line	86
Start Levee Mile	
End Levee Mile	
Location	
Category	Channels
Item	Vegetation & Obstructions
Looking downstream from Shultz Road & Road 5 1/2.	
richard_c_20110831_021.jpg

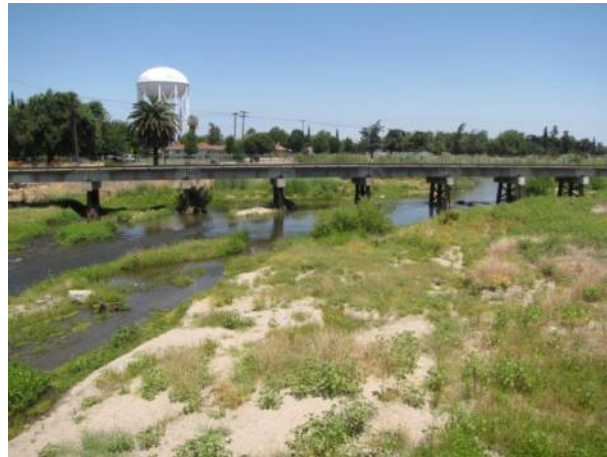
Levee Mile Report Line	31
Start Levee Mile	0.00
End Levee Mile	0.00
Location	
Category	Channels
Item	Vegetation & Obstructions
Gate way Drive crossing Fresno River. Photo taken 7-14-2011	
phillips_c_20110817_078.jpg

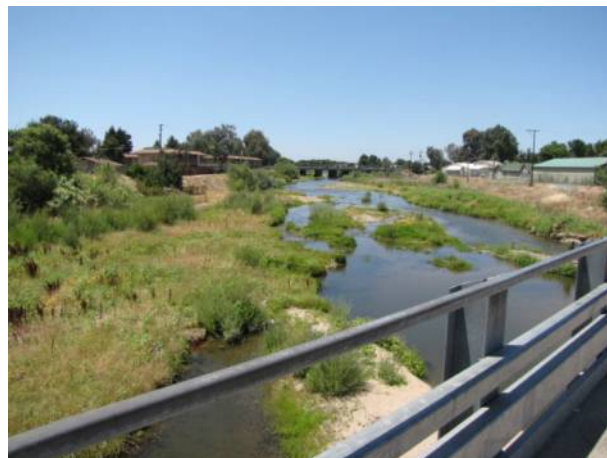
Levee Mile Report Line	36
Start Levee Mile	0.00
End Levee Mile	0.00
Location	
Category	Channels
Item	Vegetation & Obstructions
Gate way crossing the Fresno river. Photo taken 7-14-2011	
phillips_c_20110817_079.jpg
